Technical Report CHL-99-19  
September 1999

# **DMS: Diagnostic Modeling System**

## **Report 2**

### **Reduction of Sediment Shoaling of the Entrance Channel at East Pass, Florida**

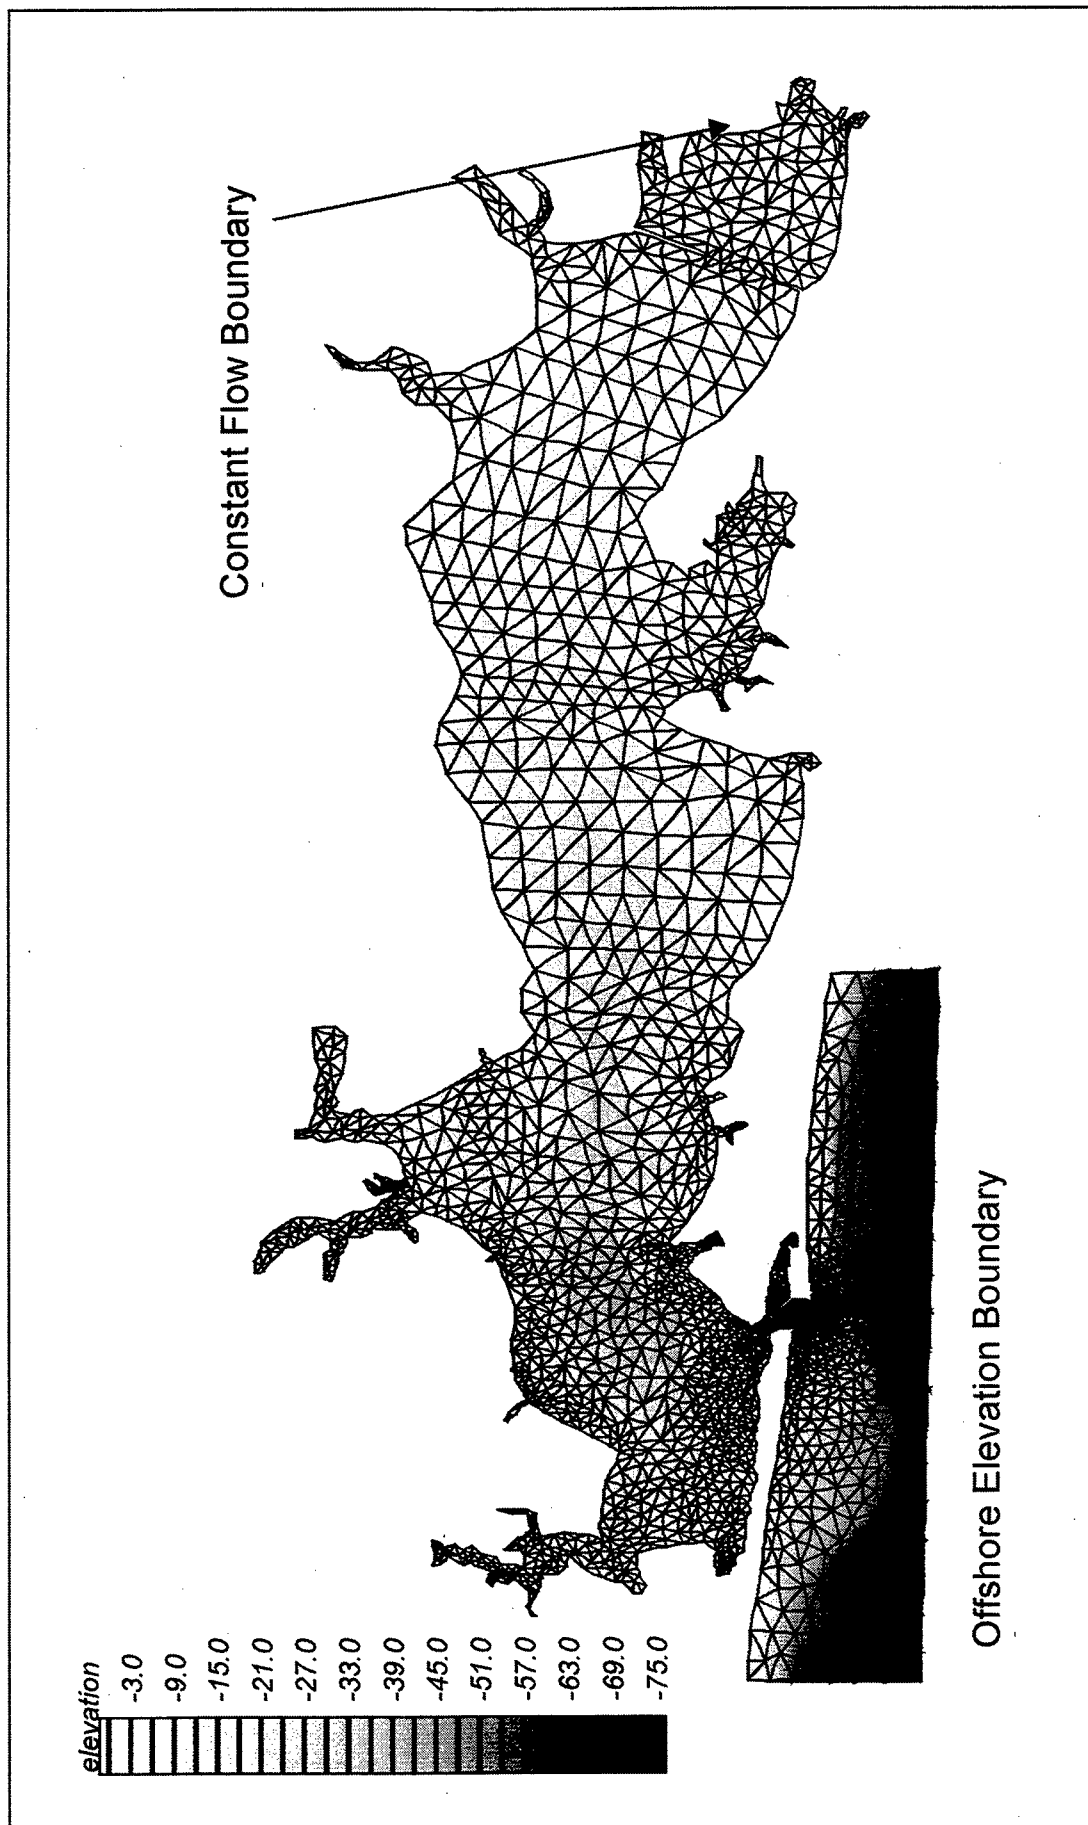
Figure 19 depicts the bathymetry input to RMA2. The constructed bathymetry reflects a combination of the following hydrographic surveys, which characterize the area given in parentheses:

- 1997 USACE SHOALS Lidar Survey (Inlet Vicinity)
- 1996 USACE SHOALS Lidar Survey (Inlet Vicinity)
- 1987 NOAA Nautical Chart #11385 (Choctawhatchee Bay)
- 1995 NOAA Nautical Chart #11388 (Gulf of Mexico)

Figure 19. RMA2 solution mesh for East Pass Inlet and vicinity

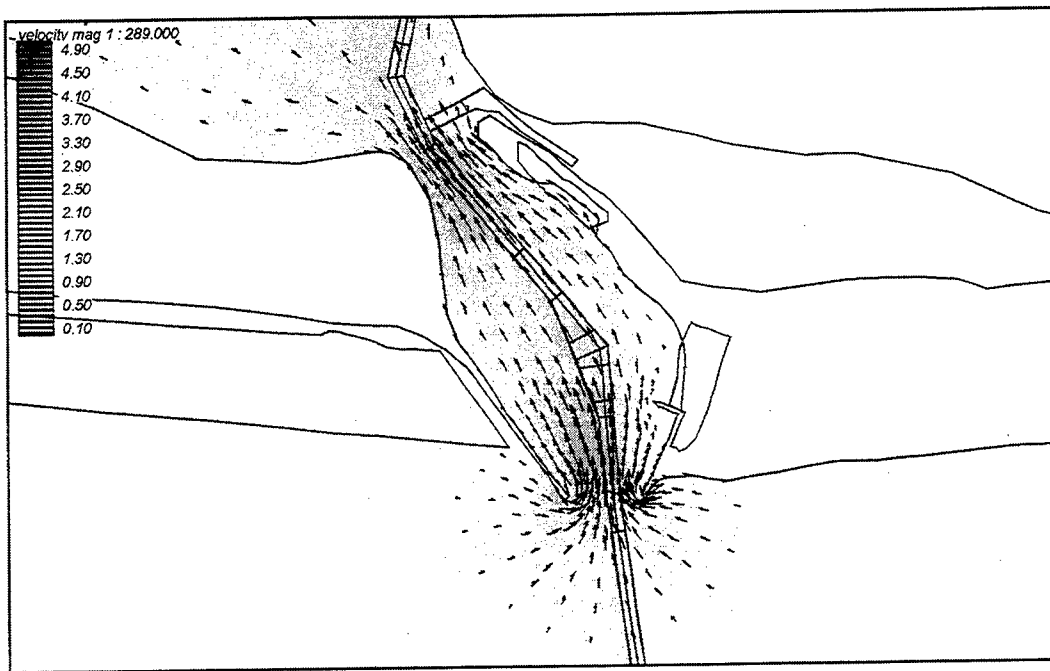
Figure 20. Velocities through East Pass Inlet on spring flood

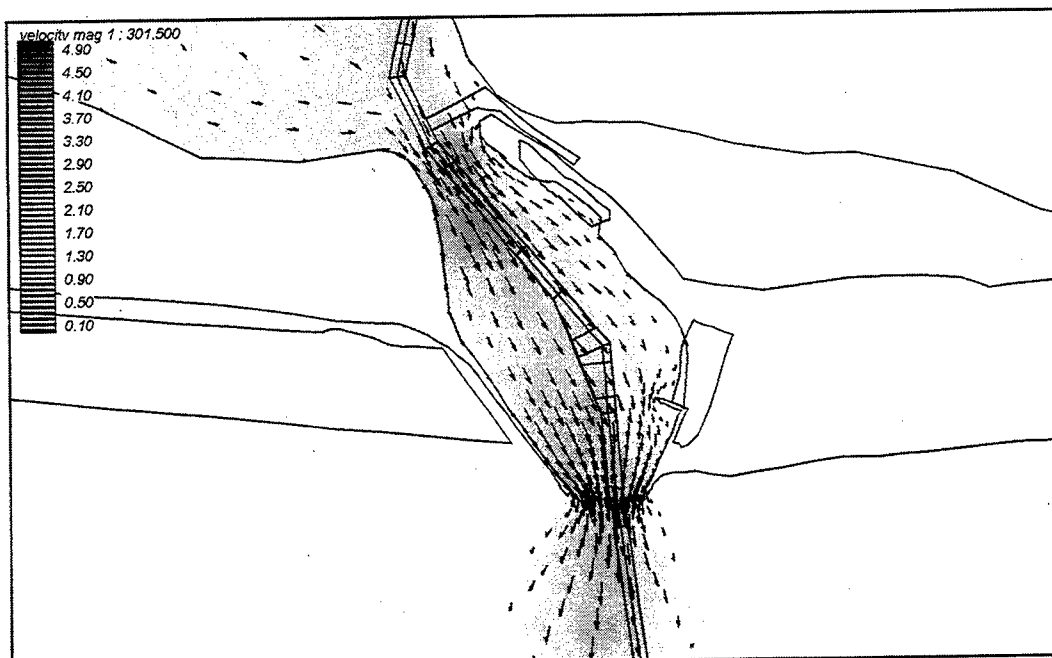
Figure 21. Velocities through East Pass Inlet on spring ebb

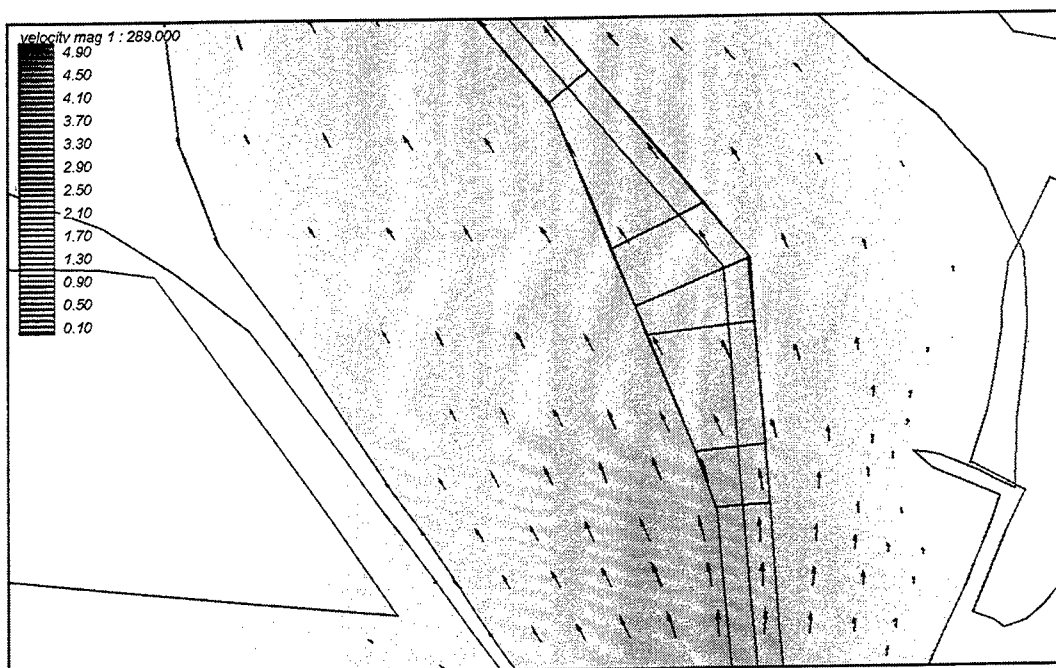
Figure 22. Velocities at channel bend on spring flood

In Chapter 3, the DMS-Manual identified two possible shoal classifications for the shoaling hot spot at the channel bend. These were shoaling caused by horizontal expansion of the channel (through shoreline recession) and shoaling caused by vertical expansion of the water column (i.e., shoaling from currents crossing the channel at an angle to the channel's axis). Figures 22 and 23 illustrate current patterns in the vicinity of this shoal. Examination of the gradient of the velocity-magnitude contours as the flow enters the inlet on flood tide (Figure 22) tests the accuracy of the horizontal expansion classification. Figure 22 shows a marked decrease in velocity magnitude traveling north through the inlet. The velocity magnitude decreases from a value of almost 4 ft/sec near the jetty tips to less than 2.5 ft/sec at the top of the channel bend. This sharp velocity decrease over a relatively short distance (~2,000 ft) verifies the choice of this shoal classification.

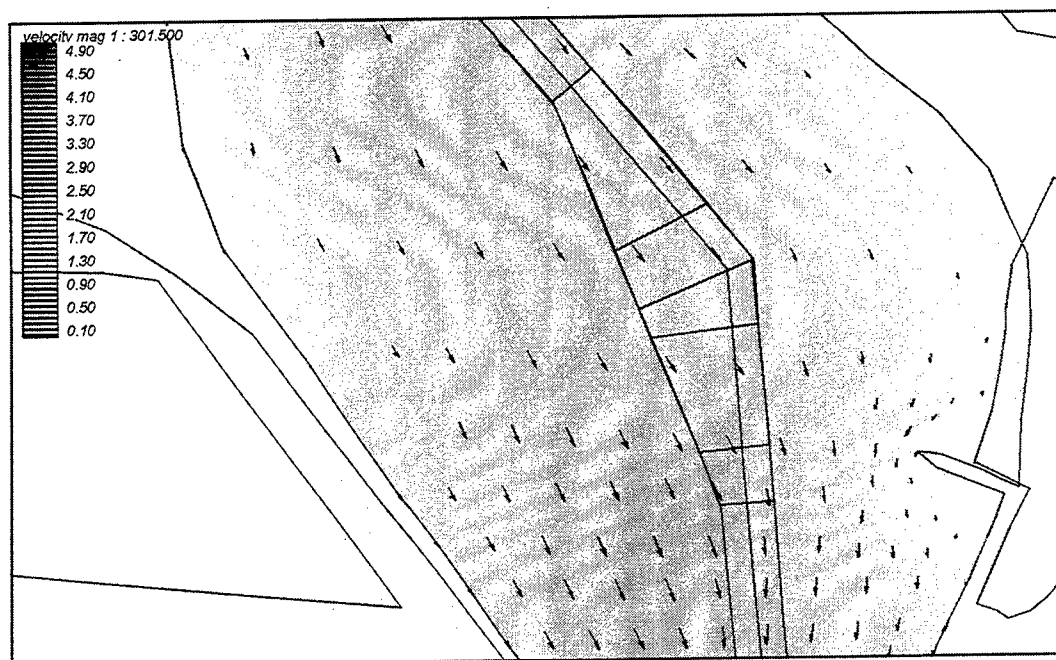
Figure 23. Velocities at channel bend on spring ebb

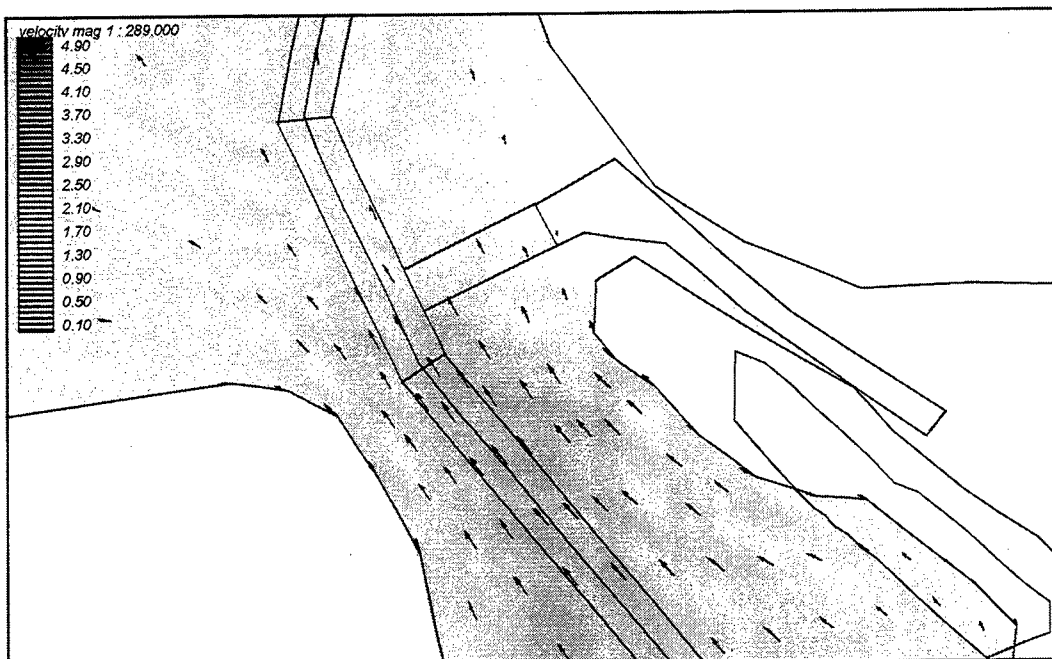
Figure 24. Velocities at Old Pass on spring flood

The second area where the manual identified more than one possible shoal type is in Old Pass channel. In this area, one of the possible classifications was *Vertical Expansions: Cross Channel Flow*. Testing of this classification involves examination of the current patterns and velocity magnitudes in the channel vicinity. Figures 24 and 25 illustrate the inlet hydrodynamics in this area. Both figures show the currents cross the channel at almost right angles to the channel axis. In addition, the figures also illustrate the marked decrease in velocity after currents enter the channel (the shift from green to blue). Both these behaviors reinforce the selection of this classification.

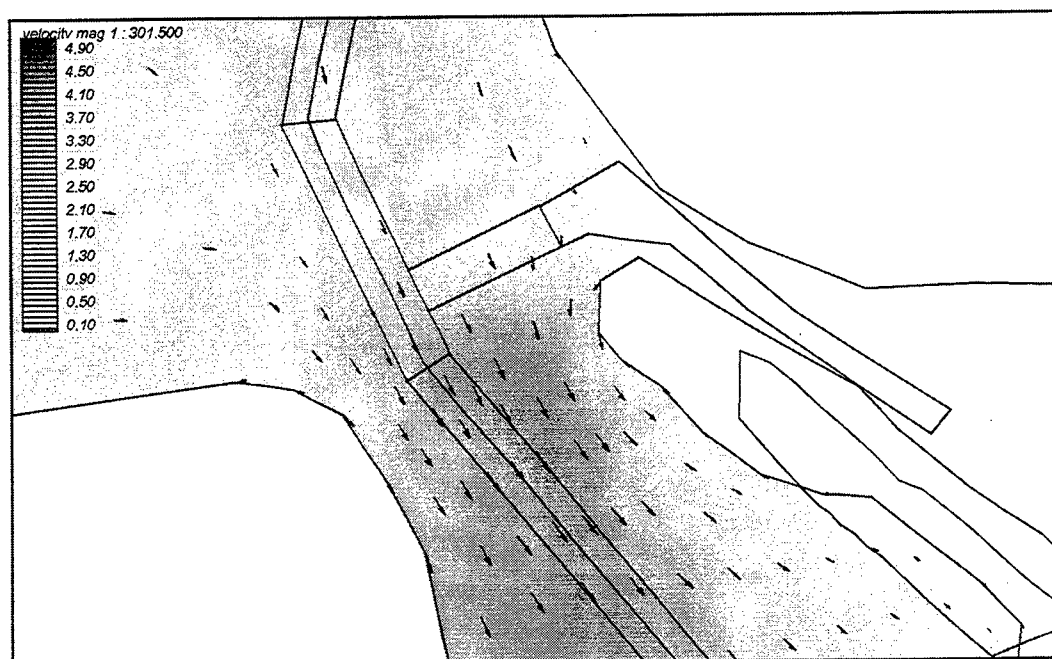
Figure 25. Velocities at Old Pass on spring ebb

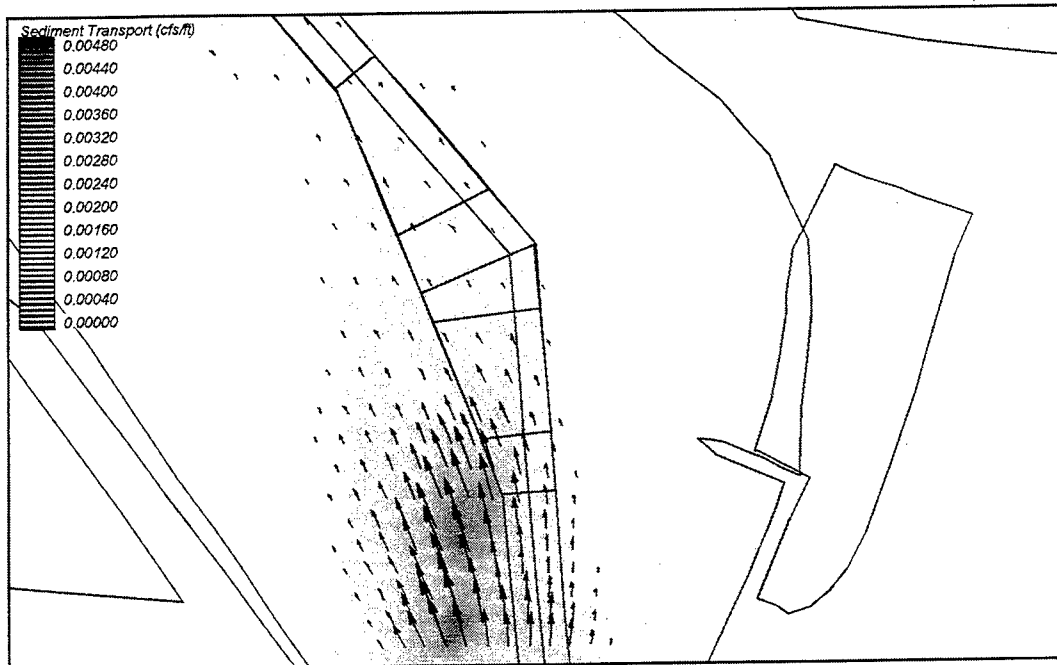
Figure 26. Sediment transport during spring flood at the channel bend

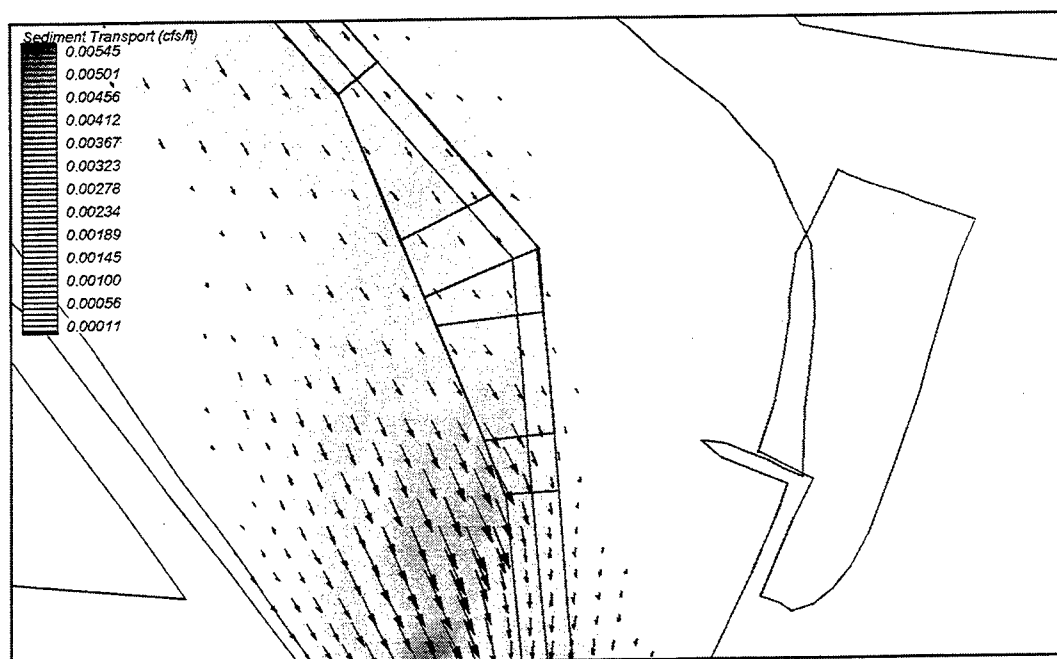
Figure 27. Sediment transport during spring ebb at the channel bend

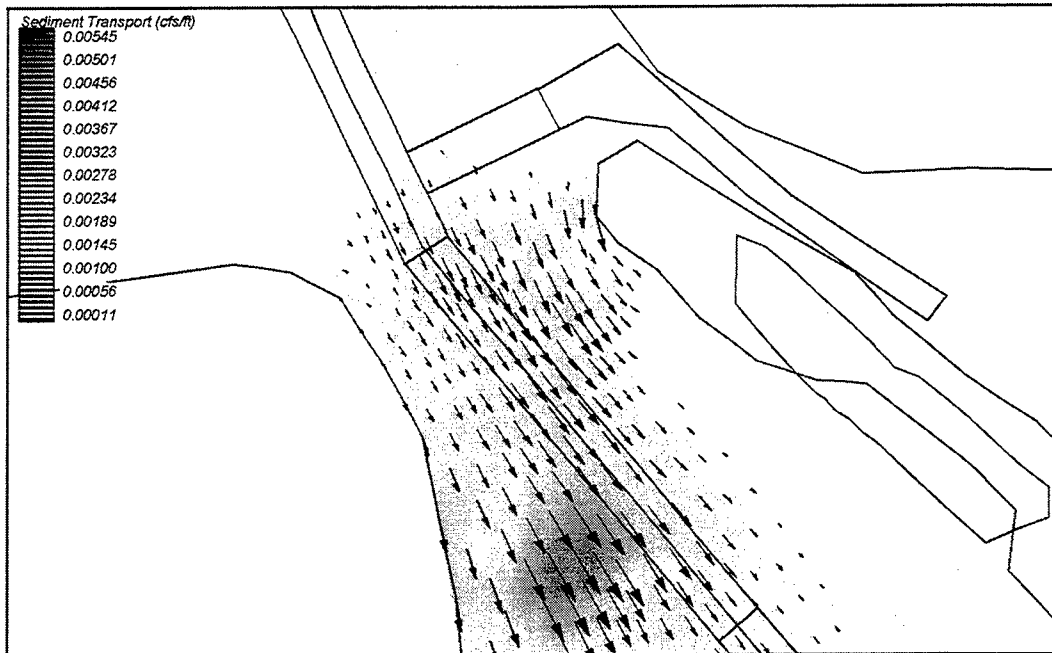
Figures 28 and 29 illustrate sediment-transport contours and vectors during spring flood and ebb near Old Pass. These figures show much less variation than the previous example. Except for a small region to the west of the area during flood (Figure 28), the contours of sediment-transport magnitude are constant (solid) in almost every area within and surrounding this shoal. Near-constant sediment-transport magnitude indicates that little sediment deposits in these areas. This result suggests a need to reevaluate the classification of this shoal. Examination of the wave climate in this area helps to clarify the classification.

Figure 28. Sediment transport during spring flood at Old Pass

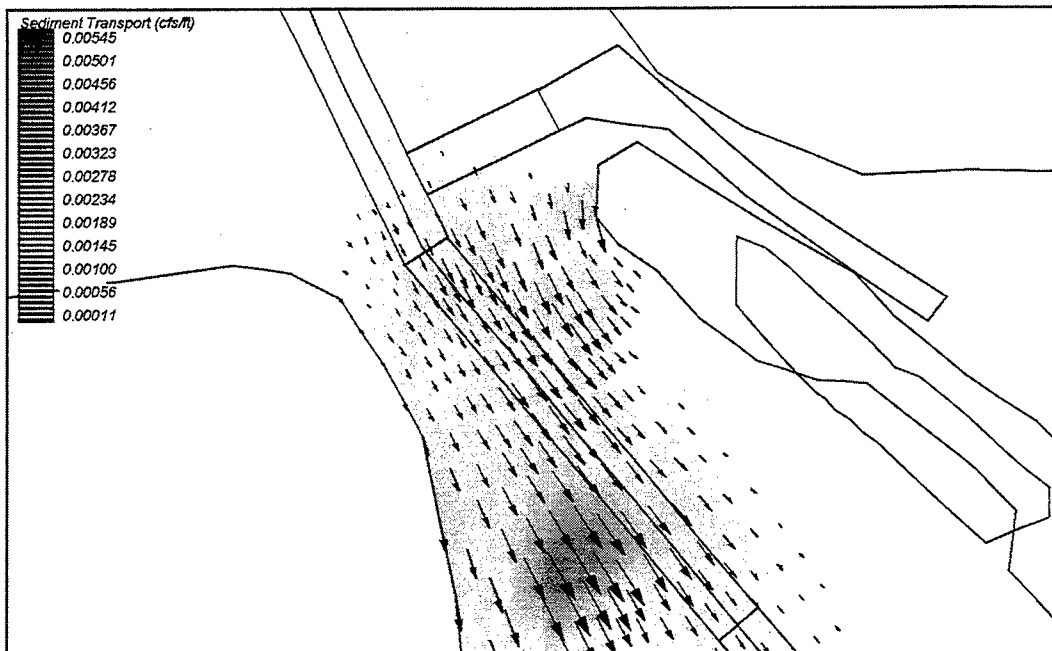
Figure 29. Sediment transport during spring ebb at Old Pass

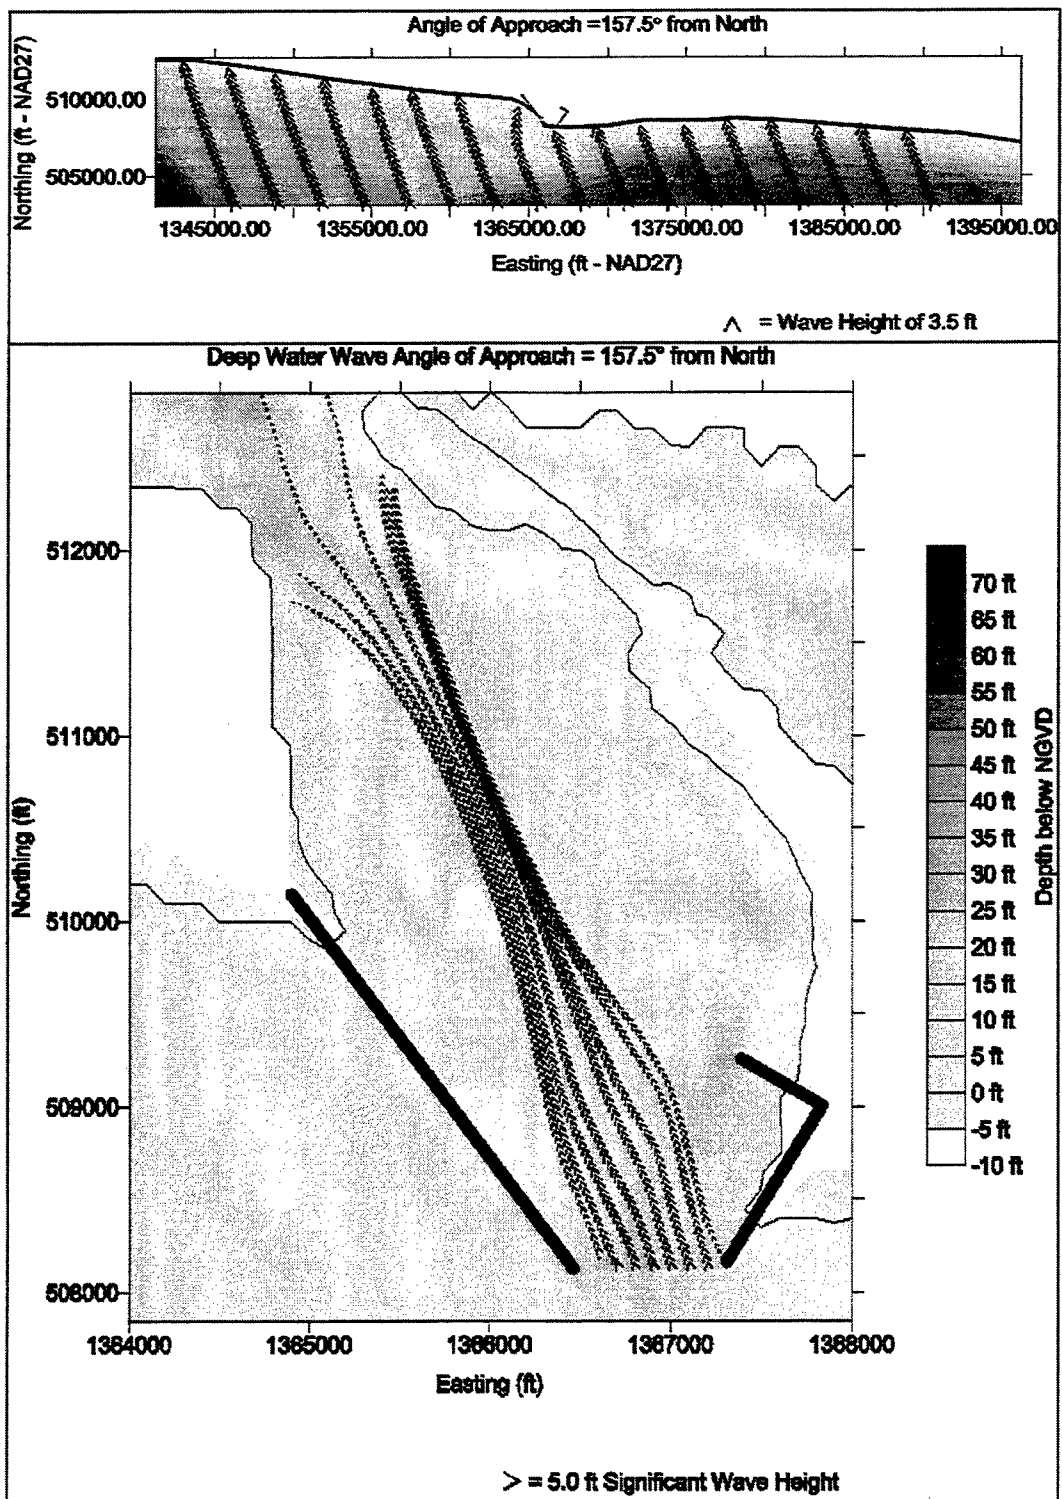
Figure 30. RCPWave wave-refraction diagrams of offshore region (above) and inlet throat (below)

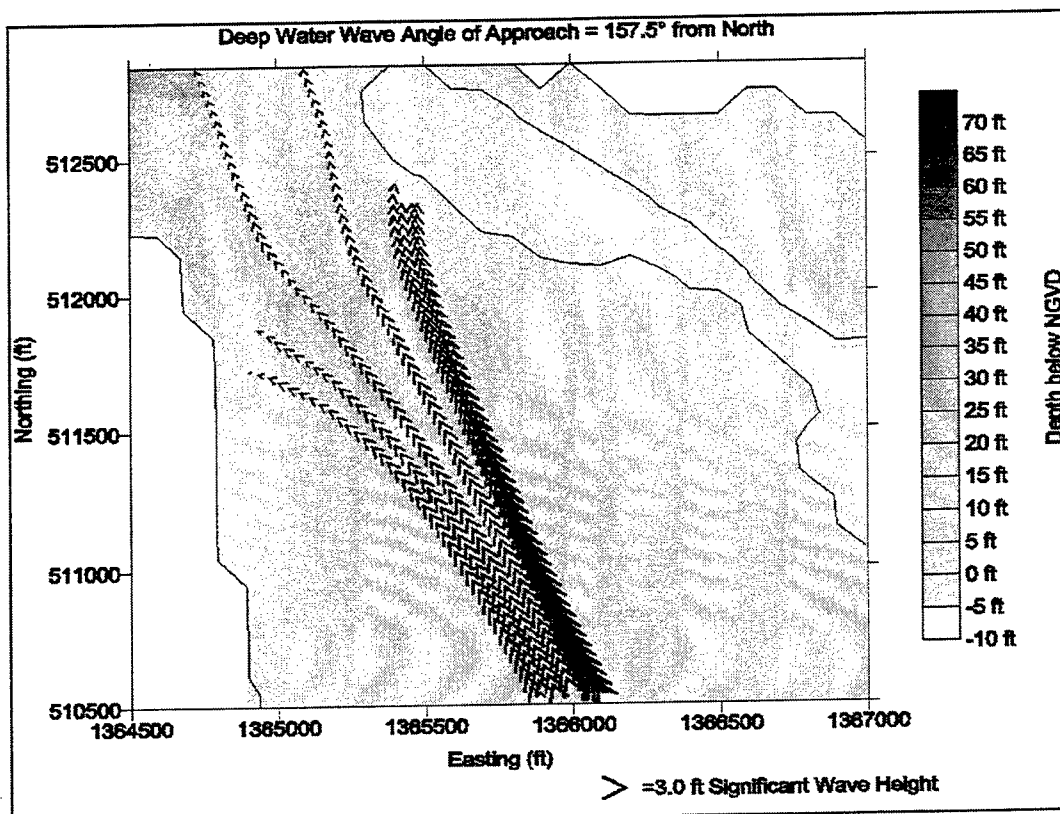
Figure 31. RCPWave wave-refraction diagram in the vicinity of Norriego Point
